7.4.0 Core Damaging Events

Rev 0708 7.4.1 USNRC HRTD

7.4.1 Three Mile Island Accident

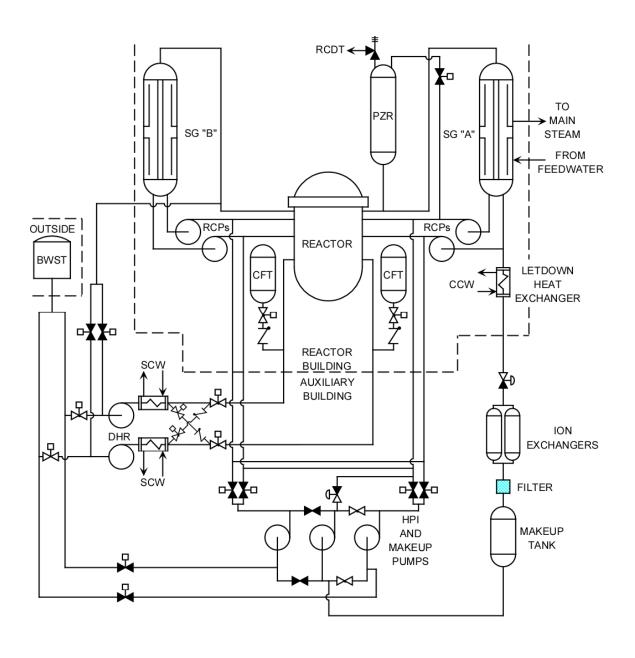
Figure 7.4-1 Basic Babcock & Wilcox Plant Systems

Just prior to the reactor trip, the pilot-operated relief valve (PORV) on the pressurizer opened as designed in response to the increasing RCS pressure, but failed to close when system pressure subsequently decreased. Figure 7.4-1 illustrates the system flowpaths. The operating crew allowed this loss of coolant to continue for more than two hours.

The only equipment failure directly involved in core damage was the failure of the PORV to close when RCS pressure dropped below the PORV open setpoint.

Ambiguous PORV position indication, poor human factors in control room design, and lack of reactor vessel level indication were design deficiencies that contributed to the accident. The position indication for the PORV did not provide a direct reading of actual valve position, but only indicated the status of the actuating solenoid. The indications for the tank that received the PORV discharge were on a back panel, not readily visible from the areas containing frequently operated equipment. These factors made it more difficult to diagnose the stuck-open PORV. There was no indication of actual water level in the reactor vessel. This deficiency made determination of RCS inventory more difficult.

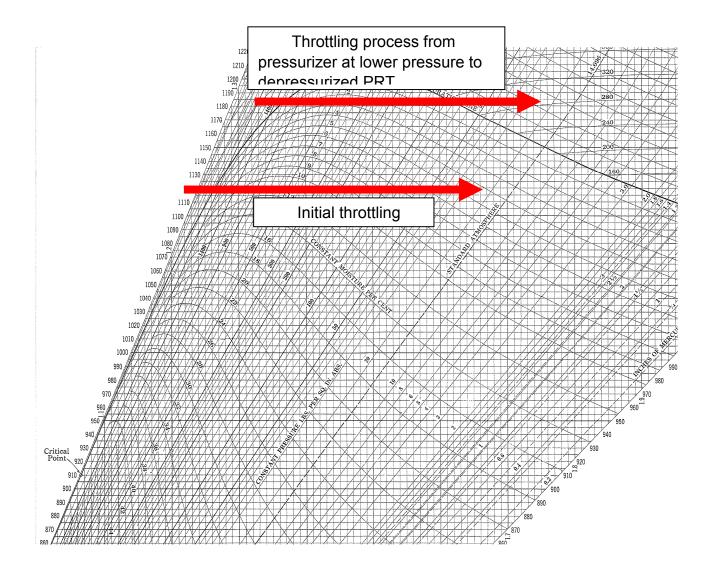
Figure 7.4-2 Mollier Diagram

The initial tail-pipe temperature of the open PORV is a function of the saturation temperature for PRT pressure. Throttling the vented steam via the PORV is a constant-enthalpy process, as illustrated by the "initial throttling" arrow in Figure 7.4-2. The properties of the vented steam vary along the constant-enthalpy line from pressurizer conditions to PRT conditions. When steam is vented at 650°F, the process remains

under the vapor dome, so the tail-pipe temperature is dictated by the PRT pressure. (Lines of constant pressure and temperature are concurrent under the vapor dome.) Even though the pressurizer steam space is at 650°F, the tail pipe temperature initially rises to only 212°F (saturation temperature for atmospheric pressure). The temperature continues to rise as PRT pressure increases, then drops when the PRT rupture disk vents the PRT to the containment atmosphere. Eventually, as illustrated by the second arrow in Figure 7.4-2, steam is vented from different pressurizer conditions at a different specific enthalpy to a depressurized PRT. The end state of this process is outside the vapor dome, resulting in a PORV tail-pipe temperature of ~ 285°F.

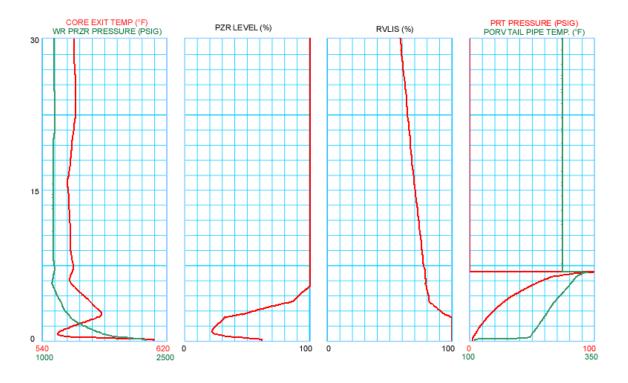
Figure 7.4-3 Plant Response to Open PORV

Figure 7.4-3 illustrates how a Westinghouse plant responds to events similar to those experienced at the outset of the TMI accident. When a PORV remains open after a reactor trip, RCS pressure drops as the steam space of the pressurizer is vented to the pressurizer relief tank (PRT). When RCS pressure drops to the saturation pressure associated with the core-exit temperature, steam formation in the core causes pressure to stabilize.

Because of steam formation in the core, water is forced into the pressurizer. Pressurizer level rises to 100%. As RCS inventory depletes, pressurizer level remains high. The steam formed at the core exit is vented out the open PORV. The pressurizer remains largely full as steam flows up the pressurizer surge line, even as the coolant in the core boils away. For these conditions (core-exit coolant saturated or superheated), the only reliable indication of RCS inventory is the reactor vessel level indication system (RVLIS). Pressurizer level is a useful measure of RCS inventory only when the coolant is subcooled at the core exit.

For these trends, the reactor tripped from 100%, one PORV was opened, and ECCS flow was disabled. These are essentially the conditions during the early portions of the TMI accident.
